Manhole Inspection Summary

Manhole # S57K__015MH

Insp Date: **2/6/09 9:06 AM**

Location Address: **3916 FOSTER-FAIT-ALLEY**

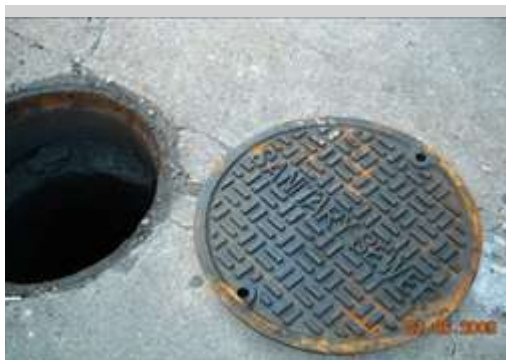
MISC.

REPLACED DAMAGED COVER

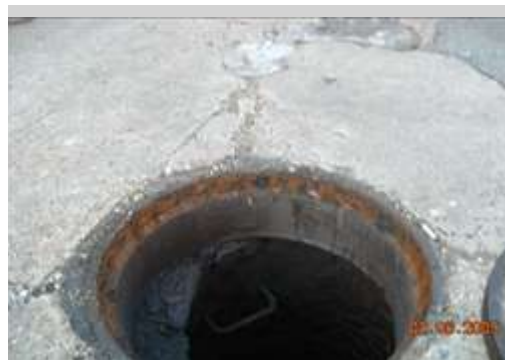
MISC.

Subject To Ponding: **Sheeting**

INFLOW EVIDENCE FROM SHEETING

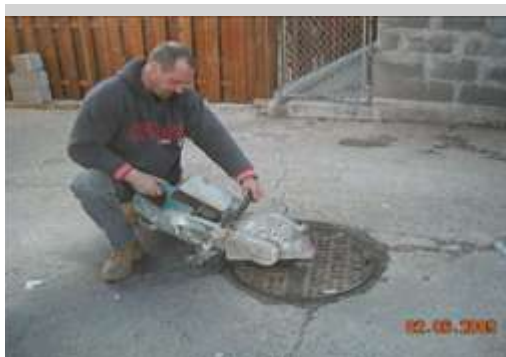
MISC.

Comments **REMOVED COVER BY CUTTING AN EXPANSION GAP THROUGH THE CENTER OF THE LID. WAS THEN ABLE TO FORCEABLY REMOVE WITH DIGGING BAR AND 16LB MAUL.**

CUT INTO COVER TO BE ABLE TO FORCEABLY REMOVED FOR INSPECTION

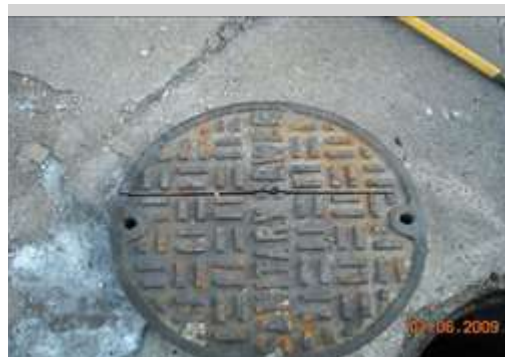
MISC

DAMAGED OLD COVER

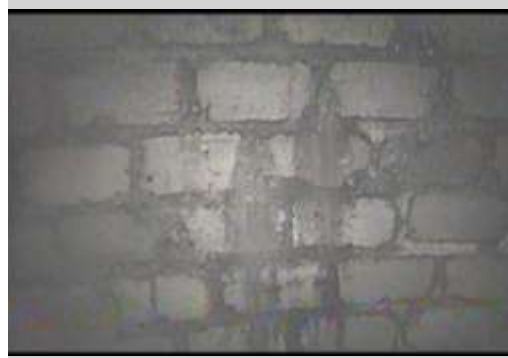
Defect 4

Infiltration: ☐ None ☐ Joint ☐ Cracks ☒ **Mortar** ☐ Roots ☐ Wall

INFILTRATION @ BARREL MORTAR

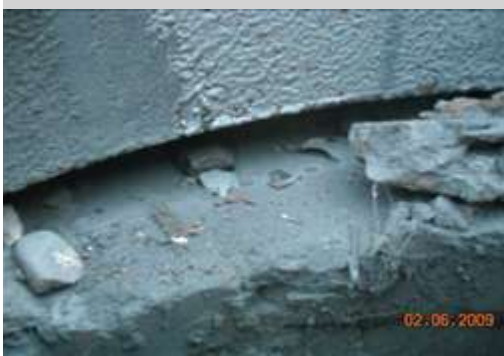
Defect 3

Condition: ☐ Sound ☒ **Cracked** ☐ Root Intrusion ☐ Loose Brick ☒ **Deteriorated**

DETERIORATED CHIMNEY

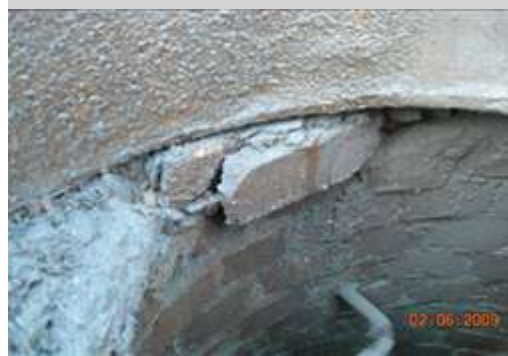
Defect 2

CRACKED CHIMNEY BRICK

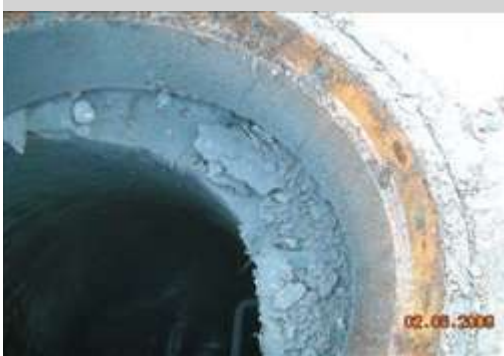
Defect 1

Frame Offset: **3** (in.) Condition: ☒ Sound ☐ Cracked ☐ Leaks

FRAME OFFSET

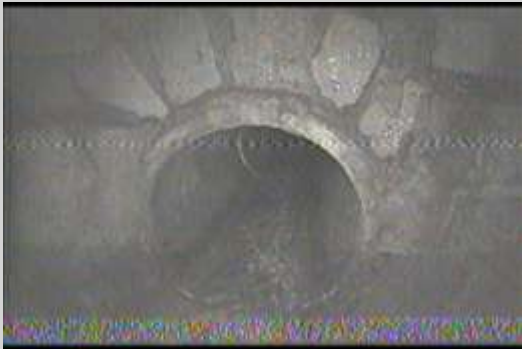
12 O'Clock Outflow

Pipe Height: **8.4** (in.) Rod and Bar (Angled)
Pipe Material: **Clay** ☐ Pipe Lined
Invert Depth: **10.90** (ft.) Flow Characteristics: **Slow**
Deposits: ☒ None ☐ Mud ☐ Sludge ☐ Debris ☐ Grease
Silt Depth: **0** (in.) Deposits Extent:
Infiltration: **Evidence** Pipe Seal Cond: **Sound**

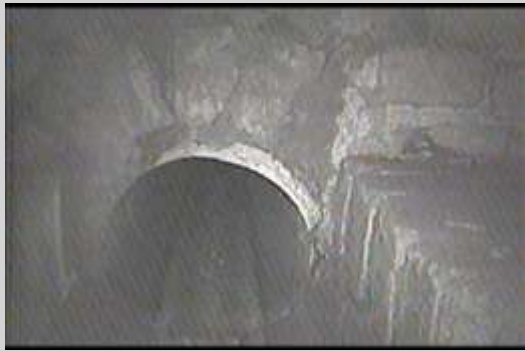
6 O'Clock Inflow

Infiltration: **Evidence** Pipe Seal Cond: **Sound**

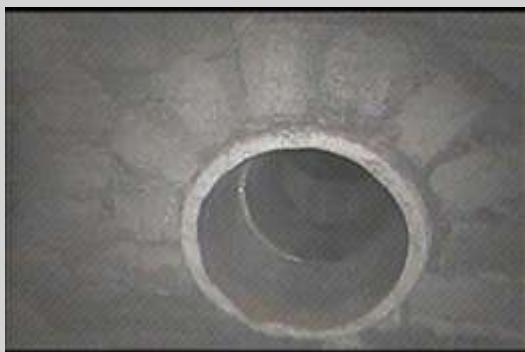
9 O'Clock Inflow

Infiltration: **Evidence** Pipe Seal Cond: **Sound**
